# Manhole Inspection Summary

Manhole # S29CC2007MH

Insp Date: **1/2/07 11:21 AM**

**Location** Address: **5508 GREENLEAF RD**

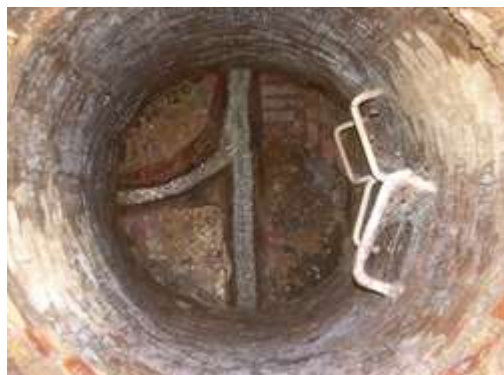
Top View

Bench debris.

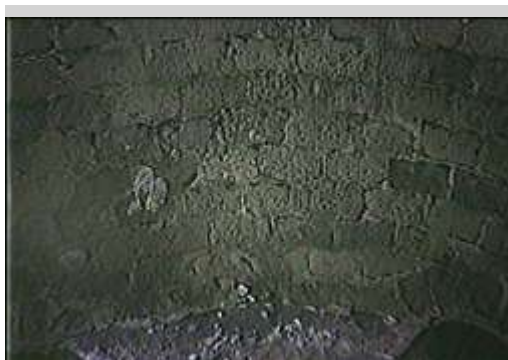
Defect

Barrel deterioration and infiltration.

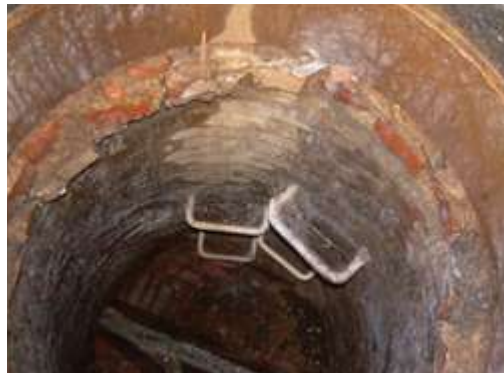
Defect

Frame leaks. Adjustment deterioration, loose brick and infiltration. Barrel infiltration - other side.

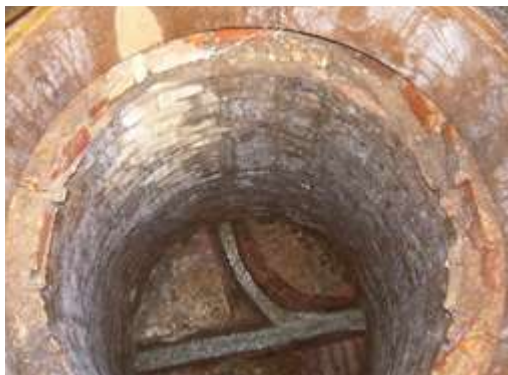
Defect

Frame leaks. Adjustment deterioration, loose brick and infiltration. Barrel infiltration.

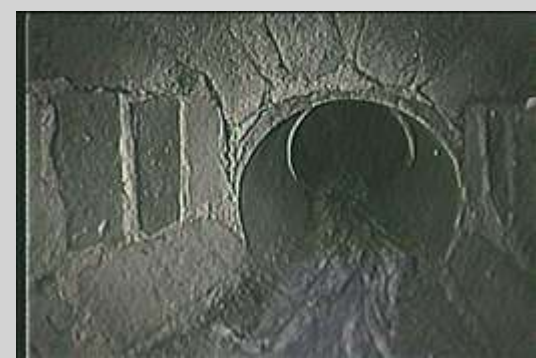
### 8 in. Circular Gravity Sewer Pipe Out @ 12 O'Clock

Infiltration: **Evidence** Pipe Seal Cond: **Cracked**

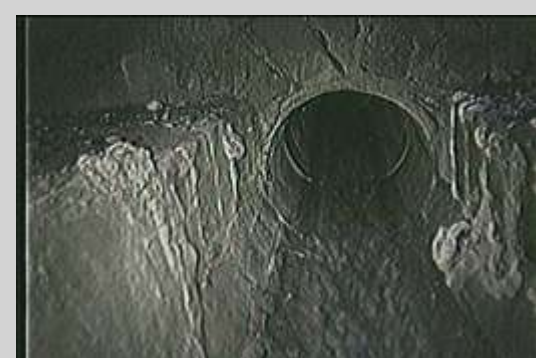
### 8 in. Circular Gravity Sewer Pipe In @ 6 O'Clock

Infiltration: **Evidence** Pipe Seal Cond: **Cracked**

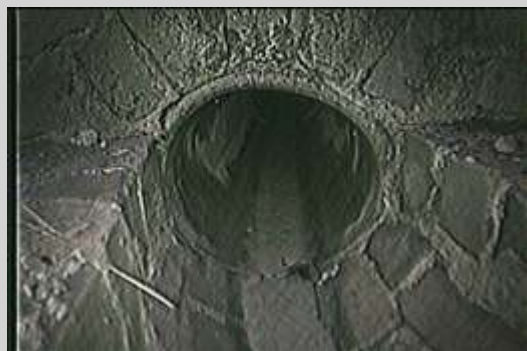
Pipe In @ 9 O'Clock

Infiltration: **Evidence** Pipe Seal Cond: **Cracked**
